Environmental Statement Volume 6 Appendix 16.1: Phase 1 Preliminary Risk Assessment

Environmental Impact Assessment

Report Number: OXF10872

Thurrock Power Ltd

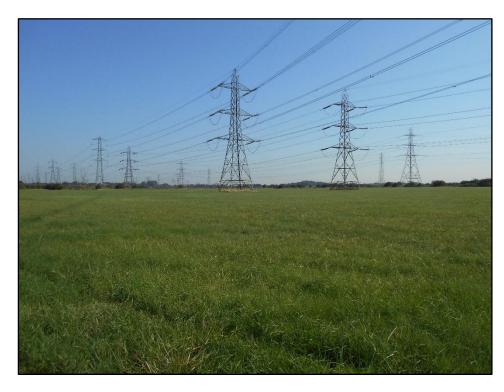
Figure 2.1: Main Development Site

- 2.1.6 The topography of the southern fields was slightly undulating with two further electricity pylons, located in the centre. Drainage ditches were located to the east, south, west and north of the southern field with another drainage ditch cutting through the northeast corner. The drainage ditches were approximately 1.00m deep and heavily vegetated with shrubs and some small trees. The vegetation formed an approximately 1.50m wide border to either side of the drainage ditches. A grass track was located on the western edge of Zone A, providing vehicular access to the southern field, drainage ditches were located on either side of the track.

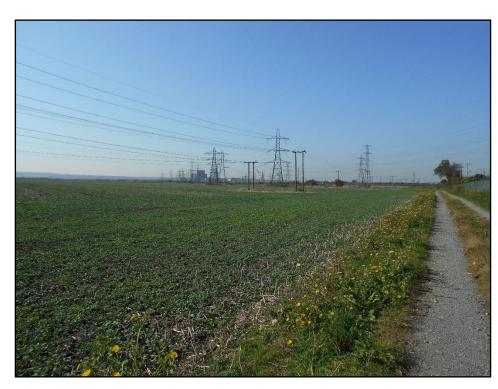
Figure 2.2: General View of Zone C.

Zone C was bisected by two drainage ditches in the east and centre running north to south across the site. The drainage ditches were culverted below the track and open within the field area. The ditches were heavily vegetated with weeds and shrubs. A mound of soil and a drain/manhole cover were noted adjacent to the eastern drainage ditch. The track extended along the entire length of Zone C providing access from Station Road. Two railway crossings were also located at the north edge of Zone C in the centre and west of the area. The western railway crossing was for vehicles and livestock with the central crossing for pedestrians only. A locked metal gate was located at the end of the track, at Station Road. A photograph of Zone C is shown in Figure 2.2.

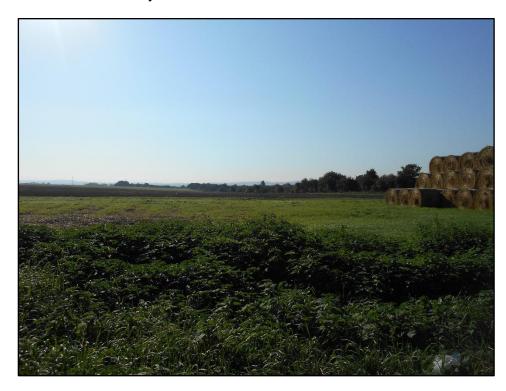
Figure 2.3: General view of Zone D2.

Zone D1 and D2 comprised part of primarily agricultural fields accessed from Station Road, located approximately 1.25km southwest of West Tilbury. The borders of the fields adjacent to Station Road comprised trees and shrubs. The irregularly shaped northern field appeared to have been recently ploughed and sloped slightly up from north to south. The smaller eastern field south of Station Road not in agricultural use was not accessed, however it appeared to be used for the storage of HDV trailers. Part of this zone also crosses through the southern corner of a larger field north of Station Road which lies adjacent to an industrial estate.

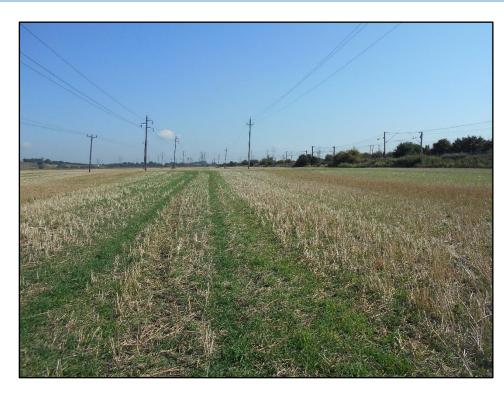
Figure 2.4: General View of Zone E.

Zones E, F1 and F3 were located to the north of the railway line, extending from the edge of Grays town to the north of Zone C. Zone E comprised a roughly rectangular field and Zones F1 and F3 comprised part of separate fields, both of which were located along the northern edge of the railway line. The railway line was raised approximately 0.50m above the fields. A drainage ditch was located along the western, northern and eastern edge of the field with a vegetated border comprising weeds, shrubs and reeds. The vegetated border was also raised slightly above the field level. The field comprised short grass (potentially recently cut) with a number of telegraph poles spanning its centre. A photograph of Zone E is shown in Figure 2.4.

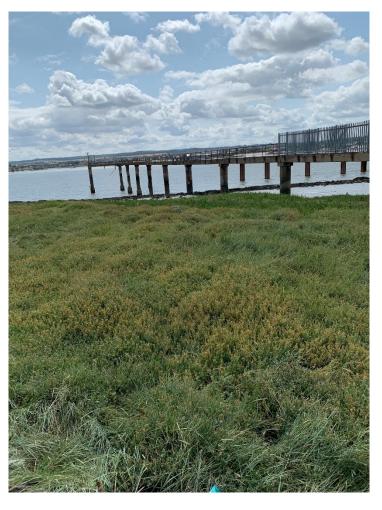
Figure 2.5: Foreshore

- 2.1.16 Zone G comprised four main parts, from south to north: Thames foreshore; the site of Tilbury B Power Station (largely demolished); mature ash fields and extraction and land-raising operations; and an agricultural field.
- 2.1.17 Other apparatus associated with the former Tilbury B Power Station primarily comprising electricity substation compounds and pylons were adjacent to the zone. A number of unnamed land drains were located predominantly on the periphery of the zone with one of these diverting across the centre of the area before discharging to, what appeared to be, a settlement pond beyond the eastern boundary of the zone. The south of the zone was occupied by the shoreline of the northern bank of the River Thames.
- 2.1.18 A photograph showing the foreshore is shown in Figure 2.5.
